Scour Depth Estimation on Abutment With HEC RAS and Some Empirical Equation

Abstract

Keywords: Scour, Numerical Modeling, HEC RAS, Batang Kalu River

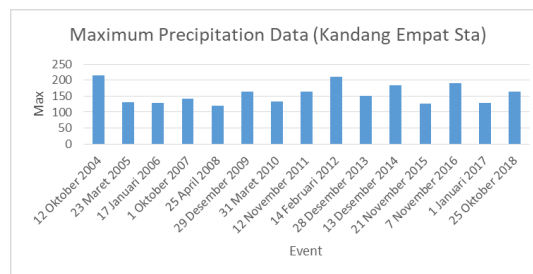
Figure 7. Maximum Precipitation Data at Kandang Empat Station

Considering the influence of the Paraman Talang and Lubuk Napar Stations on the study location, the hydrological analysis to obtain the flood discharge design was determined using the Kandang Empat Station (0° 30' 48" South and 100° 20' 6" East) with maximum rainfall data as shown in the following figure.

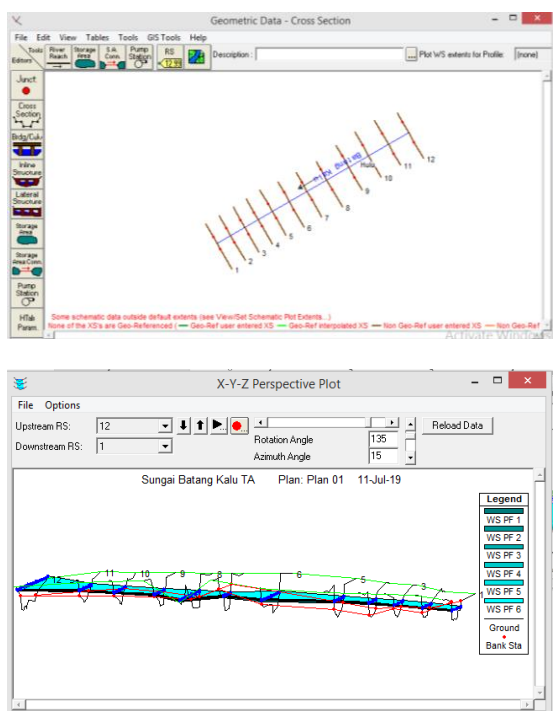
Figure 8. Layout and cross section of the river around the bridge location with HEC RAS

HEC RAS simulations were carried out to get the values of variable velocity and water level at several cross sections of the river being modeled. By using an actual river bed slope of 0.04 and a cross-section of the measurement river (Figure 8), velocity values at various discharge were obtained. Figure 8 showed the boundary conditions that taken at 50 meters each towards the upstream and downstream from bridge location with a total of 12 cross sections in the model domain. Numbering was

done by placing cross number 12 at the upstream and cross number 1 at the downstream boundaries respectively. The modeling results in Figure 8 show the water level profile at each cross section by using of 95,542 m³/sec discharge (Q at Return Period as 5 years) as a discharge that results in the scour depth closest to the real conditions. The velocity and discharge variables obtained are input to calculate the theoretical scour depth using the empirical equation as shown in the Table 2.

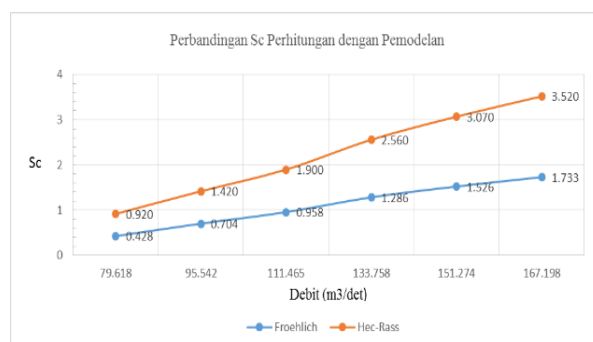
Figure 9. Comparison of Scour Depth (Sc) Against Flood Discharge (Q)

Validation is done by comparing the theoretical scour depth and the actual scour depth. The results of observations show that the scour depth is 2.83 m. From the results of the validation of the model, it is obtained the condition that is close to simulation results using flood discharge with 5 years return period. This shows that flood discharge is not the main factor

causing scour. Increased velocity due to increased river bed steepness can be expected as a variable that results in velocity increase resulting increasing of scour depth. The graph of the relationship of scour value to flood discharge can be seen in the graph at Figure 9.
